HOUSATONIC RIVER BASIN  
WASHINGTON, MASSACHUSETTS

WASHINGTON MOUNTAIN LAKE DAM  
MA 00318

PHASE I INSPECTION REPORT  
NATIONAL DAM INSPECTION PROGRAM

DECEMBER 1979

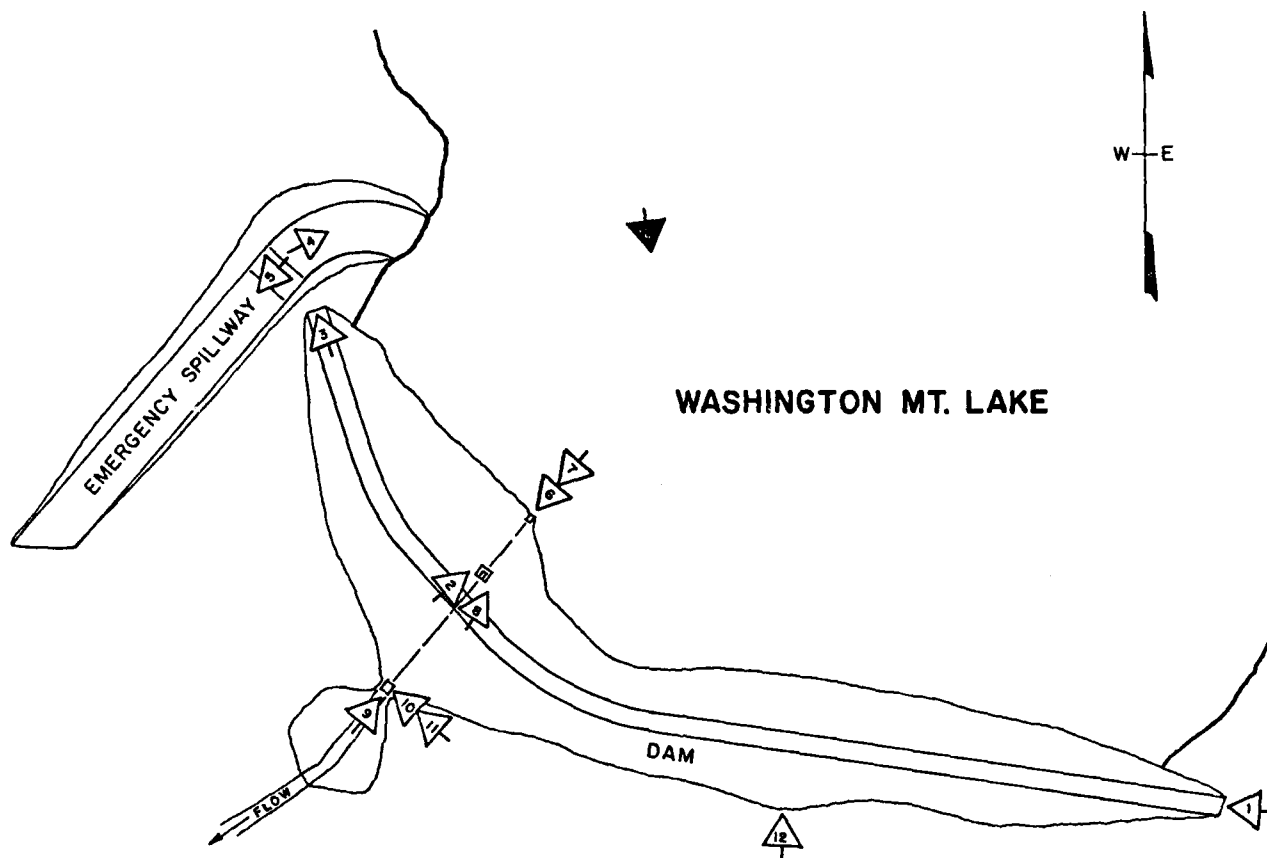
The emergency spillway is in good condition. Some vehicular traffic on the slope of the spillway has caused ruts. The top of the dam at the spillway (right) end of the dam is 1.2 feet lower than the design finish grade. It appears that this portion of the dam was originally constructed to this lower elevation. The guide berm bordering the left downstream side of the spillway is not protected against erosion is not adequate along the berm and erosion will result when the spillway is functioning.

Photo 3 - Overview of  
right abutment and  
emergency spillway look-  
ing westerly from dam  
crest. Note the wheel  
ruts on right slope of  
spillway left center  
of photo.
